REPORT NUMBER: 100758576MID-001
ORIGINAL ISSUE DATE: JUNE 27, 2012

TEST REPORT

PRODUCT EVALUATED:
3'0" x 3'6" Single Swing Flush Door with Through Penetrations Filled with Fire Door Caulk.

EVALUATION PROPERTY:
90 Minute Positive Pressure Fire Endurance

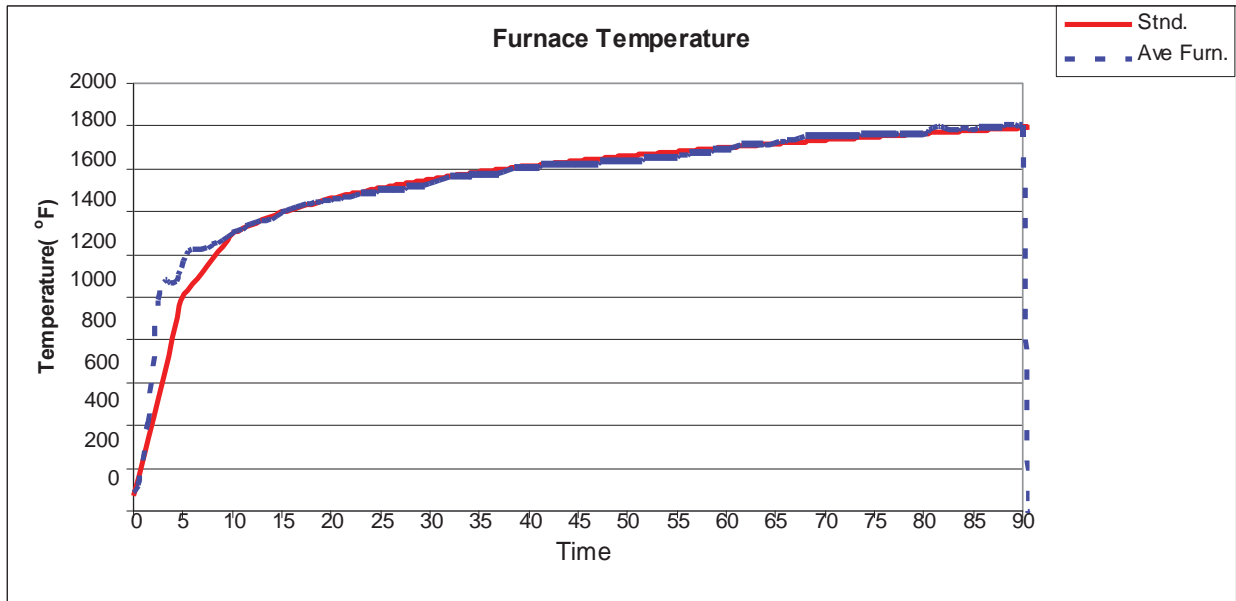
FIGURE 1 · FURNACE TEMPERATURES, ASSEMBLY 1

After positioning the assembly frame over the furnace opening, the burners were ignited and a timer started. Temperatures within the furnace were monitored using thermocouples and the data recorded. The burners were controlled to keep the furnace temperatures within the allowable limits specified in the test standards. These temperature data are included in this report.

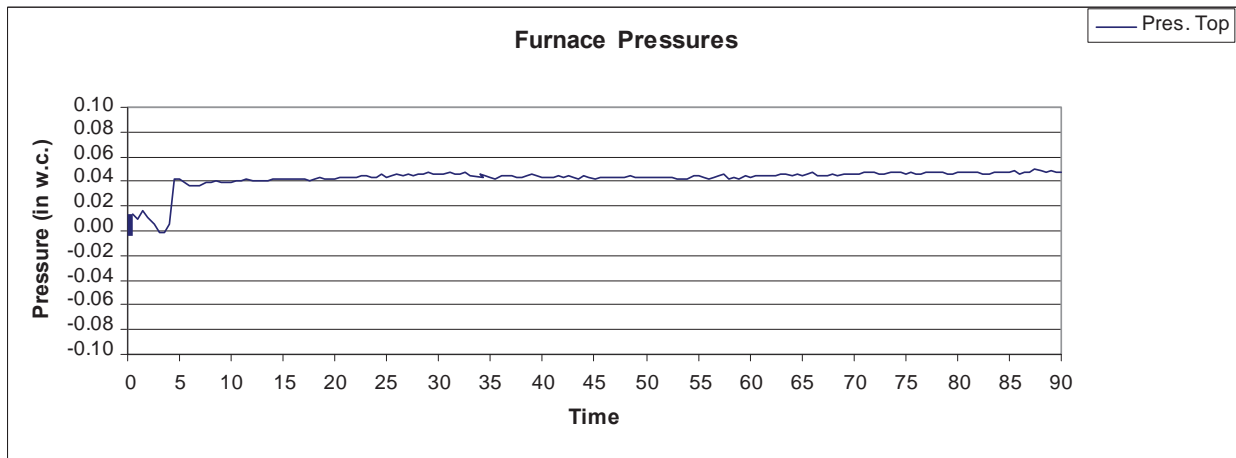
FIGURE 2 · FURNACE PRESSURES, ASSEMBLY 1

A pressure tap was installed through the furnace wall adjacent to the test assembly at one height (top of door) to measure furnace pressure. The pressure plane at the top of the door within the furnace was maintained at 0.04 inches of water column to simulate testing the top portion of a door. The pressure data is included in this report.

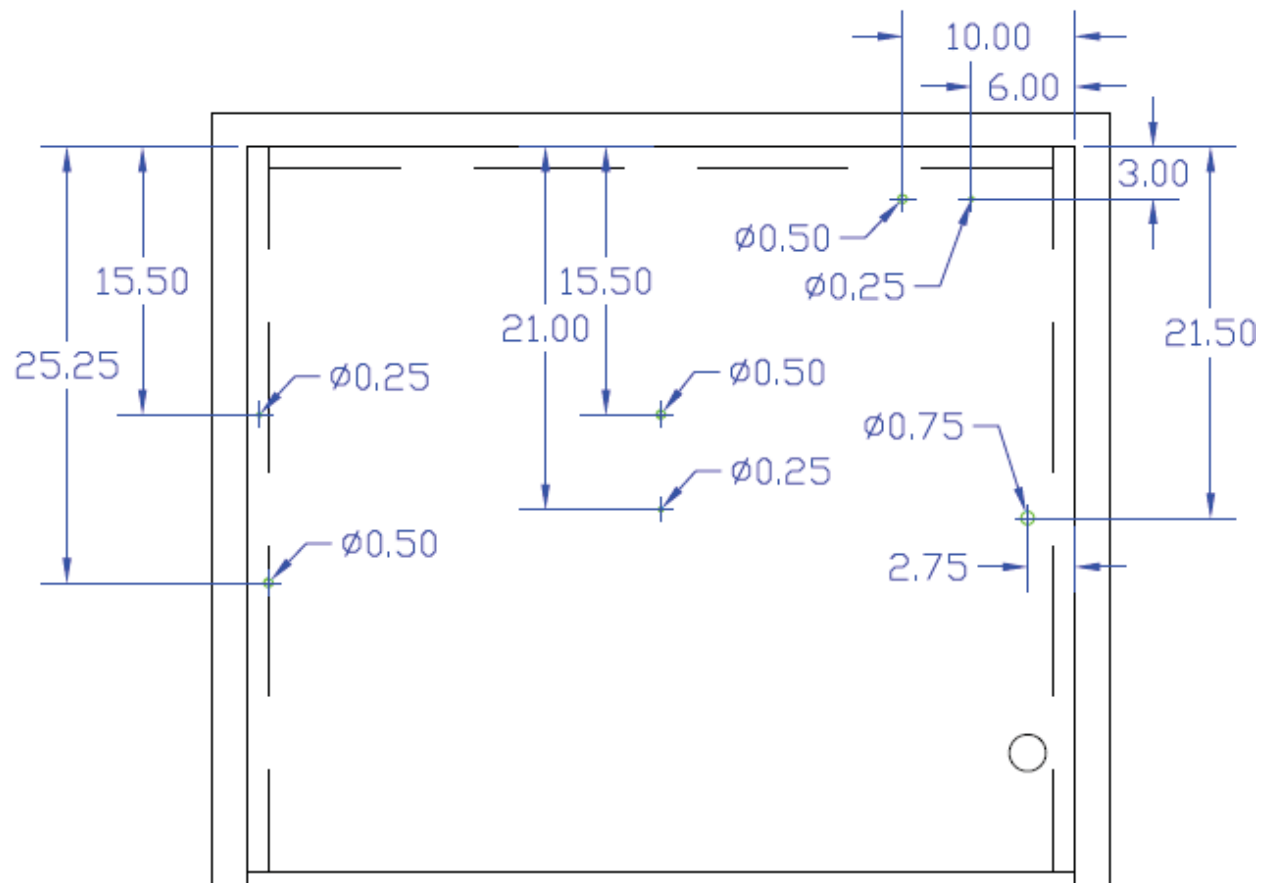
FIGURE 10.15.1 ASSEMBLY MAP

Door	Size/Configuration	Nominal 3'0" wide x 3'6" high x 1-3/4" single swing flush door.
	Door Skin	Door skin: Birch Veneer
	Stiles	Composite.
	Door Top Rail	Composite.
	Door Bottom Rail	Composite.
	Door Core	MDS non-combustible core.
Frame	Size/Configuration	3'0" wide x 3'6" high listed steel frame.
	Material	16ga.
	Wall Type	8" CMU
Hardware	Lockset	Simulated
	Hinges	Simulated
	Edge seal	1 strip of Lorient 1.5" intumescent applied to jambs.
Through Penetrations	All penetrations were filled with Fire Door Caulk.	Core: $\leq 1/4''$, $\leq 1/2''$, $\leq 1/4''$. Stile & Rail: $\leq 1/2''$, $\leq 1/4''$. ***See Figure 3 for a map of these through penetrations. ***No voids in the caulk or penetrations were allowed.

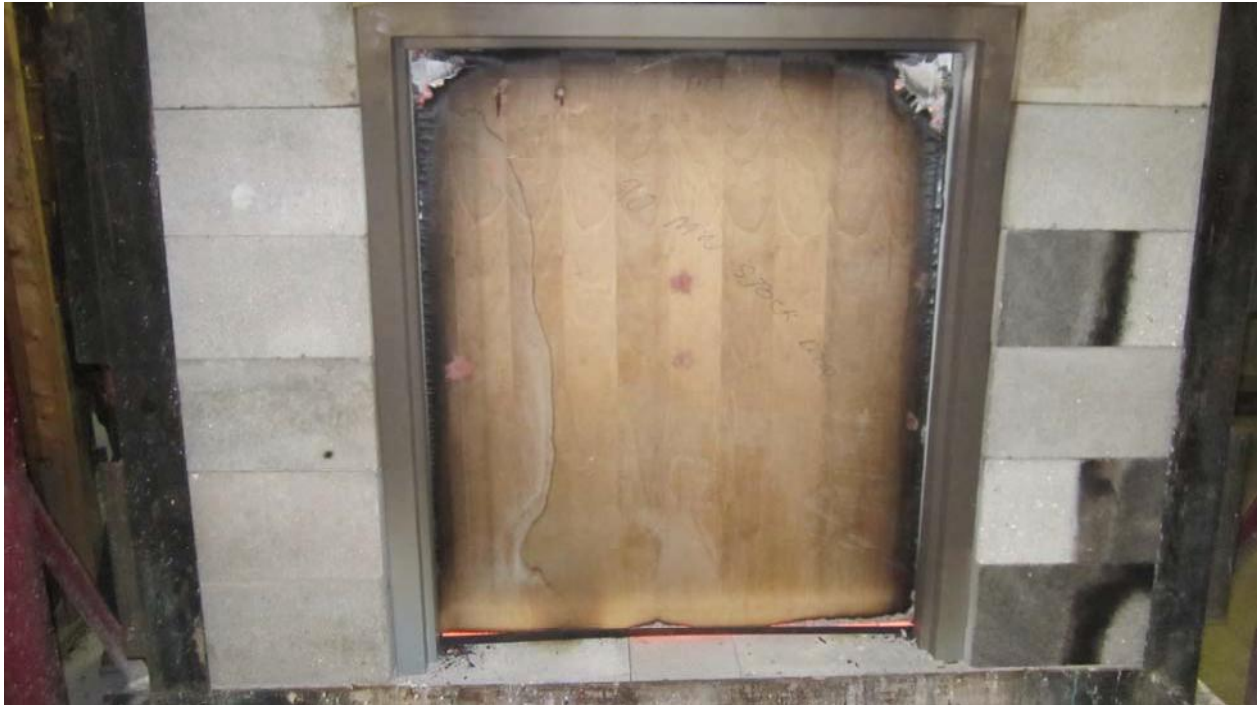
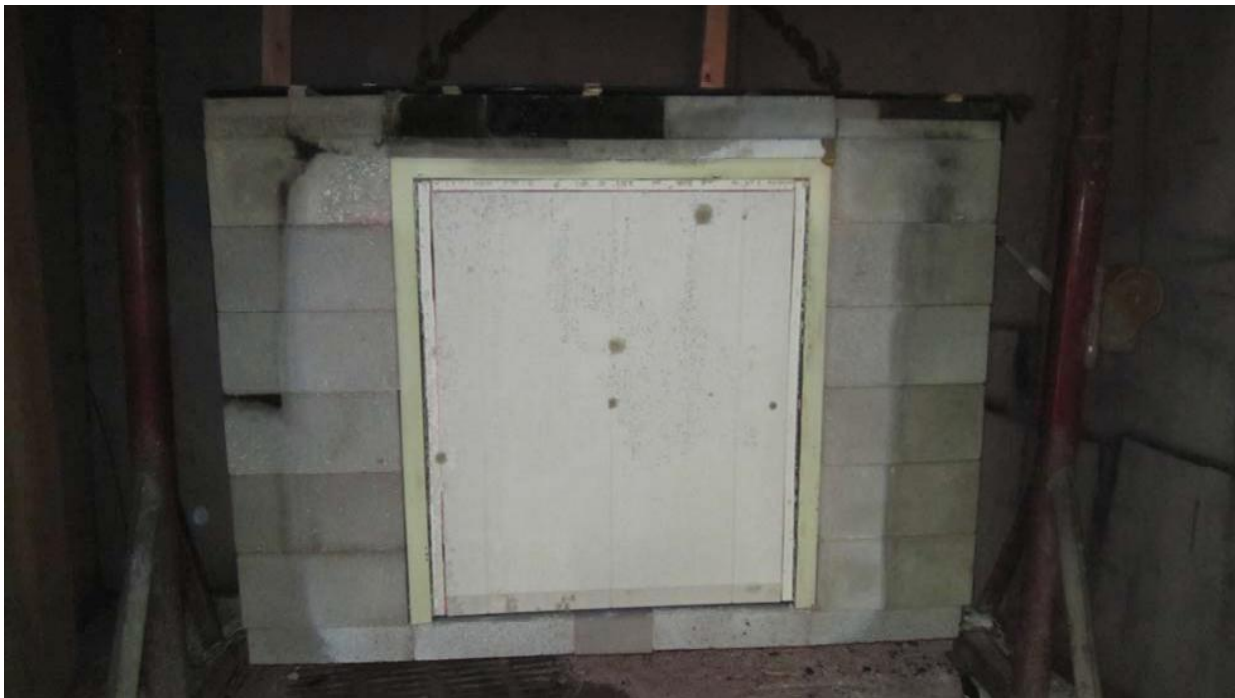
PHOTOGRAPHS, ASSEMBLY 1
Fire Endurance

TIME	UNEXPOSED FACE
00:00	Assembly tight to frame.
01:23	Smoke from around perimeter of door.
02:28	Smoke ceases.
04:19	Light smoke from head of door.
07:15	Discoloration of hinge side and top hinge corner.
09:10	Discoloration of latch side and top latch corner.
30:00	No significant change.
45:00	No significant change.
47:40	Glow at top hinge corner.
60:00	Glow and char at bottom hinge corner of door.
71:09	Top hinge corner is deteriorating.
75:00	No change at filled holes.
90:00	Test stop.

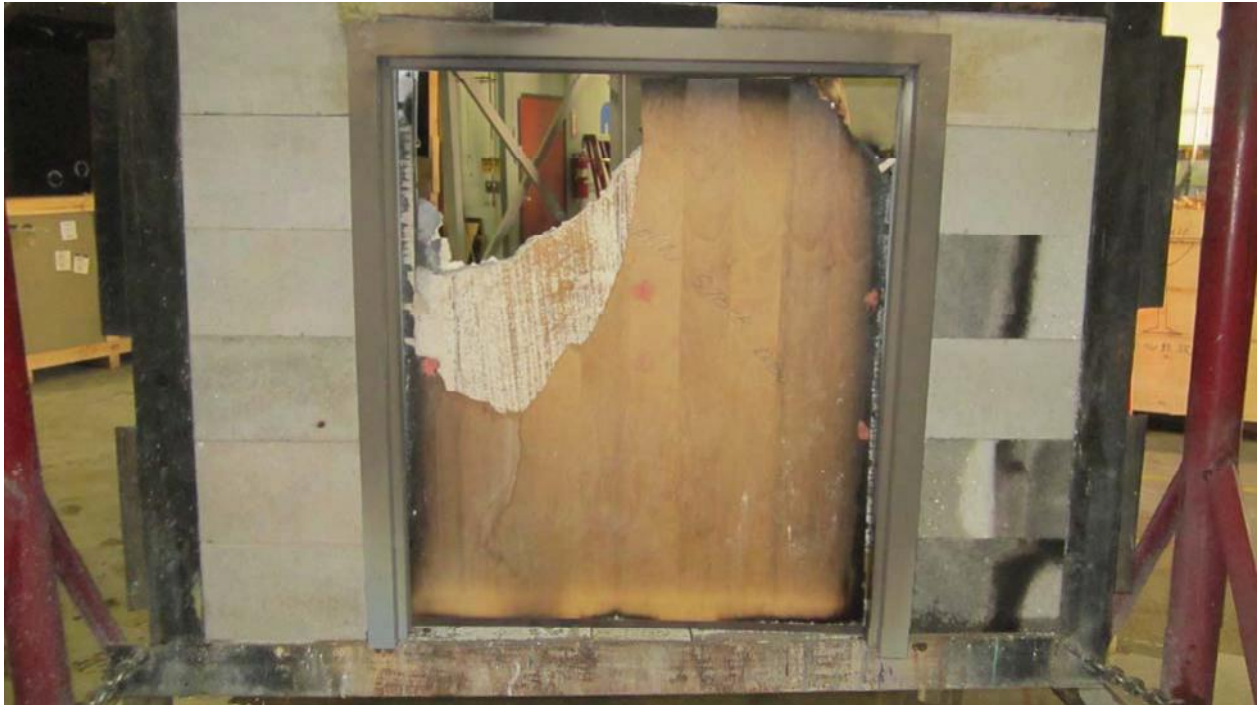
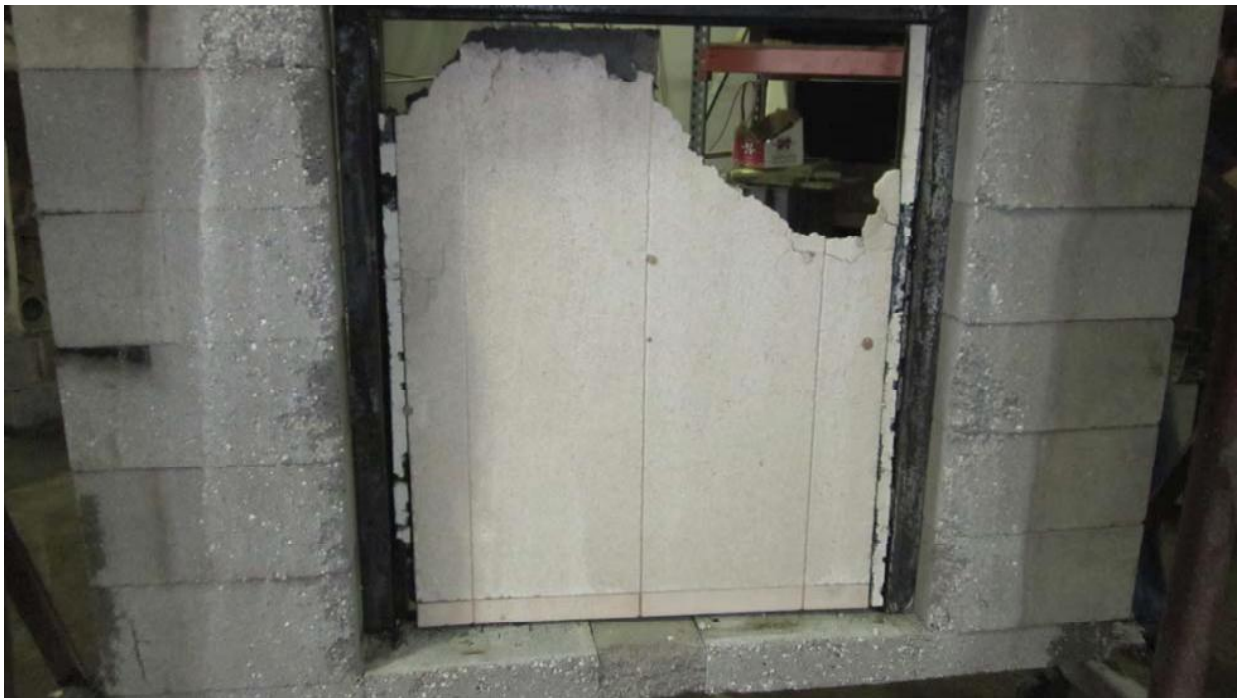
PHOTOGRAPHS, ASSEMBLY 1
Hose Stream

A Hose-Stream Test was conducted for 18.3 seconds based on a total assembly area of 12.22 square feet and a required duration of 1.5 seconds per square foot of assembly area at 30 psi. At the conclusion of the Hose-Stream test, all of the through penetrations being evaluated remained filled with the intumescent caulk. The top corners of the door were removed from the opening during the Hose-Stream test, this failure of the door occurred away from the evaluated areas and was not caused by the through penetrations or application of the Fire Door Caulk.
